**Stabilization and Safekeeping of the Tailing Pond Novat at
Baia Borsa, Maramures, Romania**

ANNEX to

FINAL REPORT

Photographic Documentation of Finalized Works

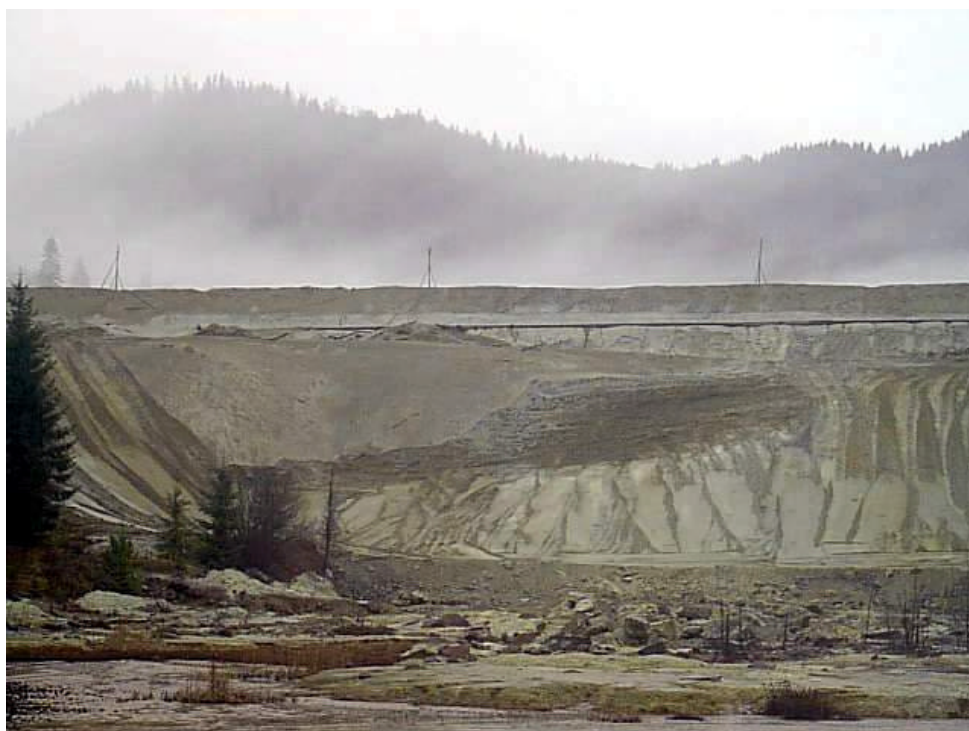
View from the exfiltration pond upstream to the rehabilitated (more gentle) slope of the tailings dam. Below the pipeline the intermediate berm can be seen; at the toe a new drainage system was built in. (photo: Stematiu)

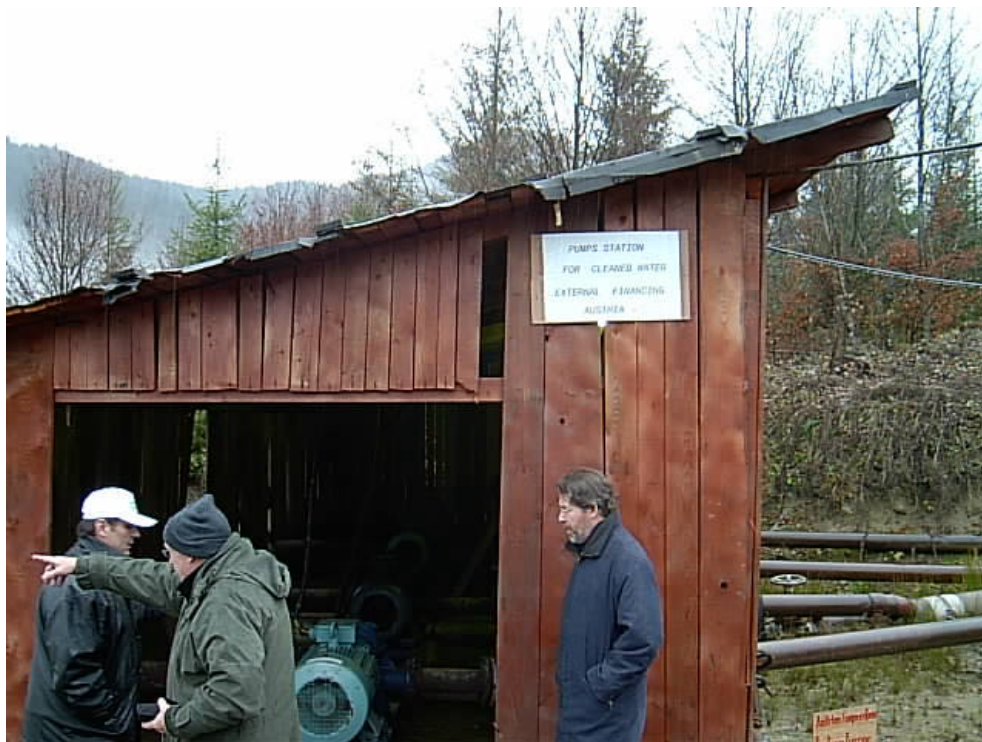
The repaired pumping station for cleaned water (main tailings pond): Mr Mois (REMIN envir. dep., Prof. Lorber/AT and Mr Zinke/AT).

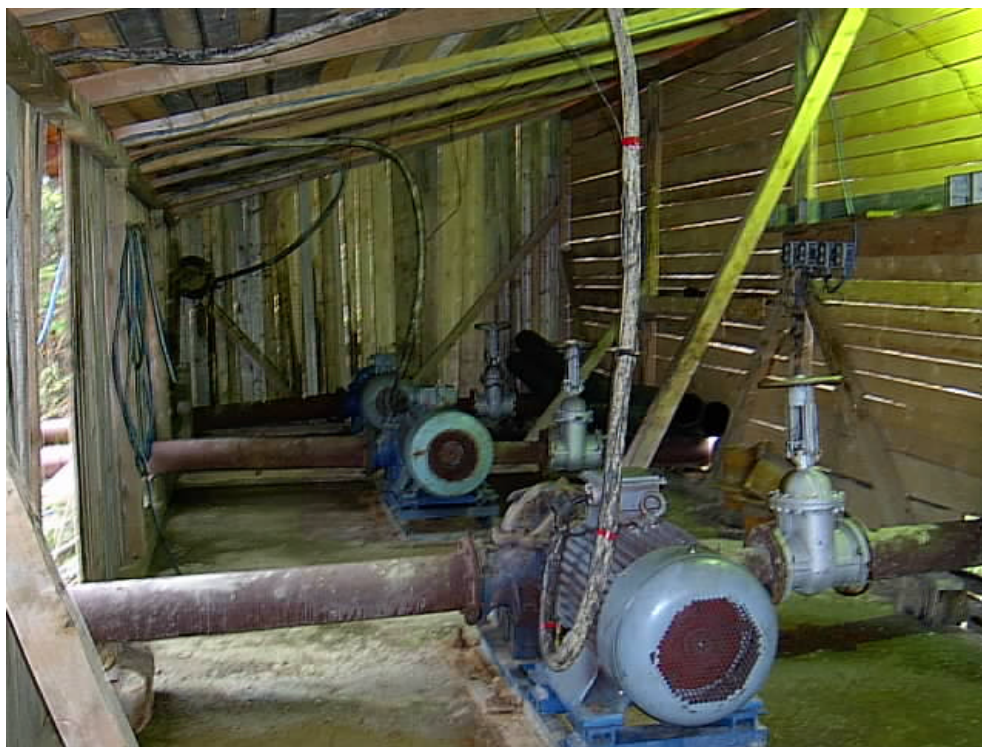
The new pumps at the repaired pumping station of the main tailings pond

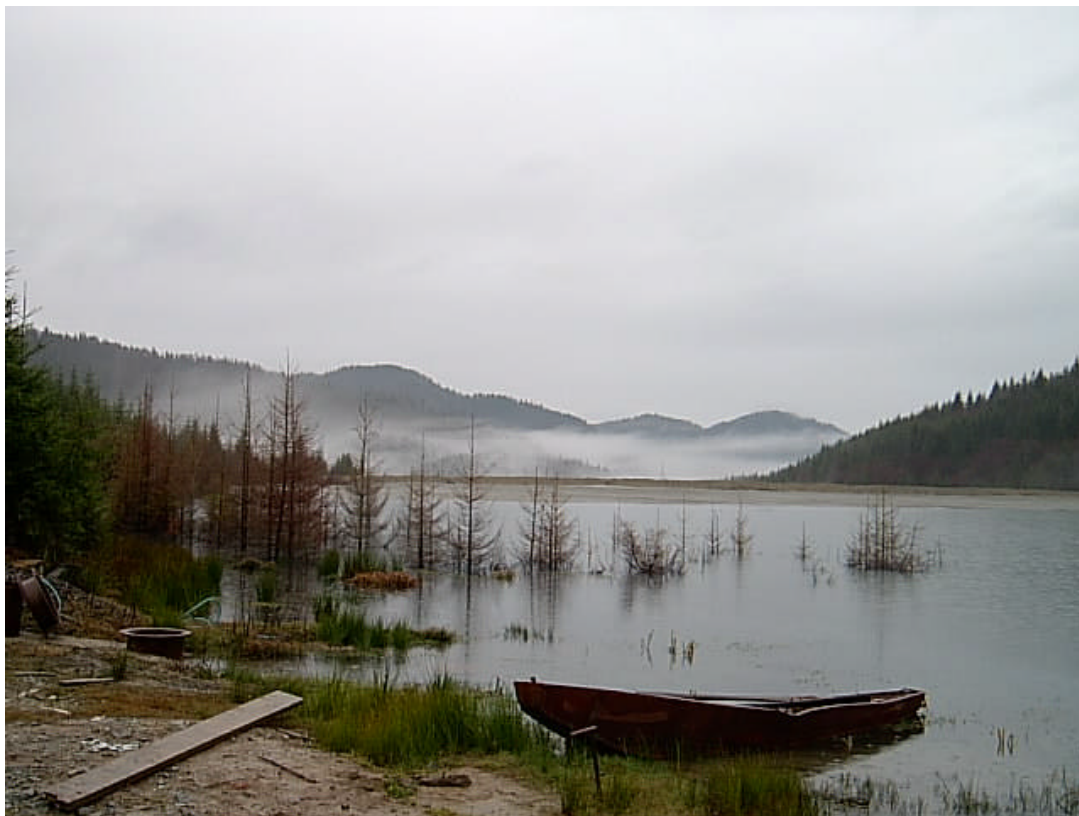
View from the banks of the tailings pond at the pumping station towards the crest of the dam (with the beach in front).

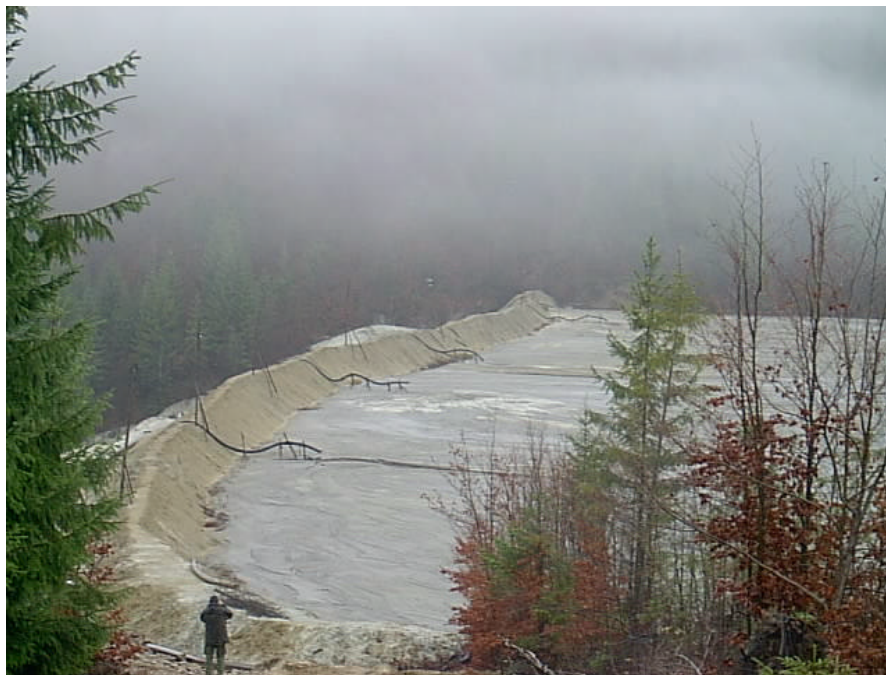
View to the main tailings pond (with the raised crest for increased freeboard at left and the expanded beach at right)

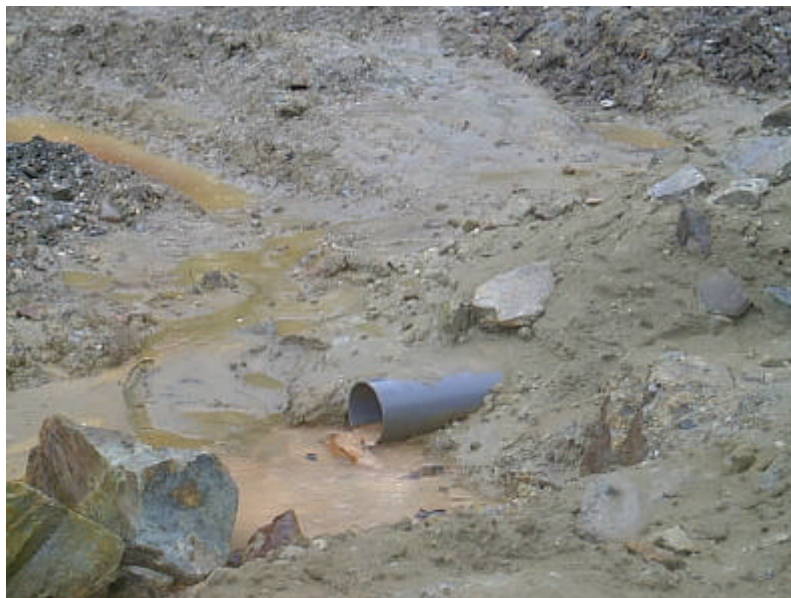
Detail from the toe of the main dam: As a result of the new drainage system, pipes collect seepage and spring water in a controlled way and discharge it downstream to the exfiltration pond.

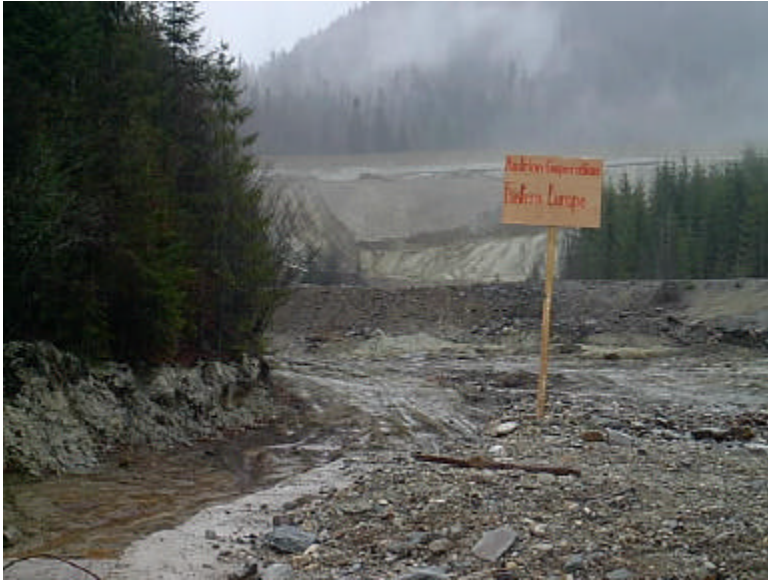
Upstream view from the exfiltration pond: The tailings deposited here after the accident in March 2000 were moved out (upstream) in order to increase the pond's capacity for collecting seepage water of the tailings pond.

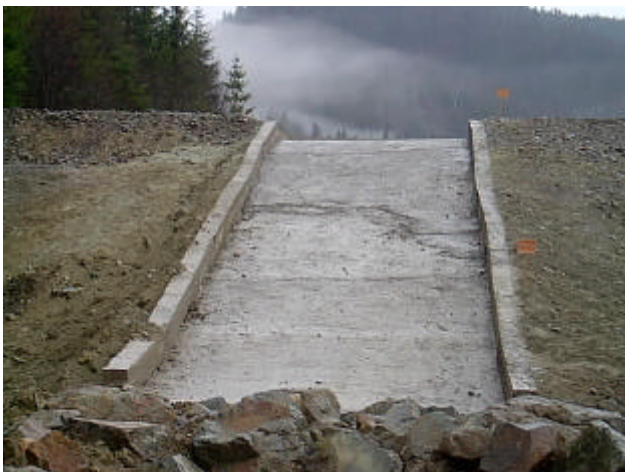
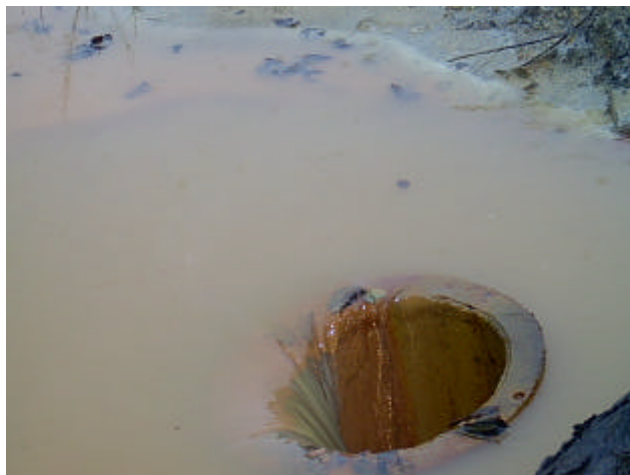
Exfiltration pond: The embankment was re-shaped and made water-tight with a geo-membrane (photo on top). A new emergency spillway was built on the central section of the dam (photo below).

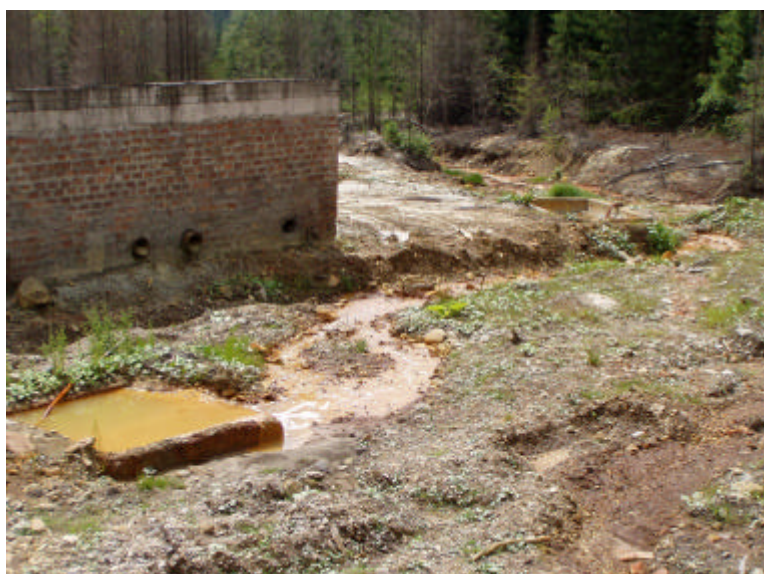
Penstock at the lowest point of the exfiltration pond (photo on top): From here seepage water is designed to go through the pipe via the exfiltration pond pumping station back up to the main pond (closed circuit).

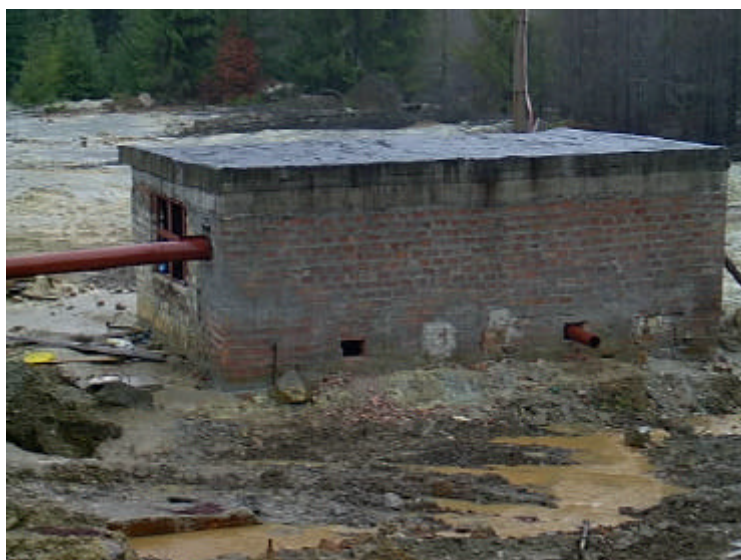
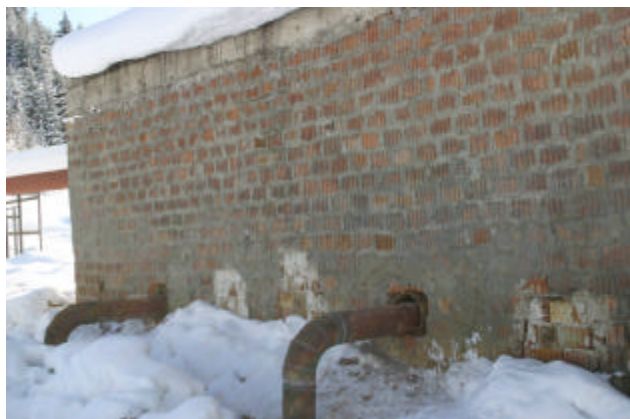
The pumping station of the exfiltration pond was mostly destroyed by the March 2000 accident and only re-built in 2004. At the left bottom (see both the photo on top from July 2004 (by Zinke) and the photo below from early November 2004), the outlet of the pond (penstock) still discharges contaminated seepage water around the house into Novat creek.

Since mid November 2004, the exfiltration pond outlet is re-connected to the pumps of the pond station: All seepage water is pumped back up to the main tailings pond. The contamination of the Vaser creek valley is stopped.

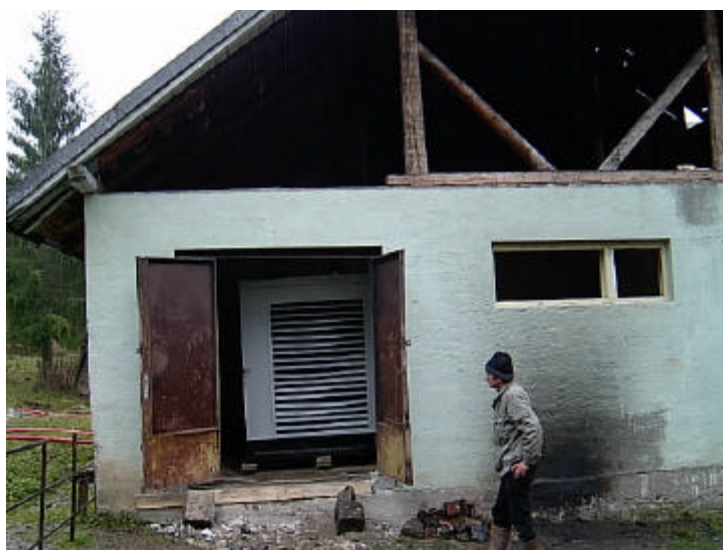
Inside view of the pumping station (exfiltration pond): 3 new pumps were installed and restitute since mid November 2004 the long-years needed pipeline link between the exfiltration pond and the main pond.

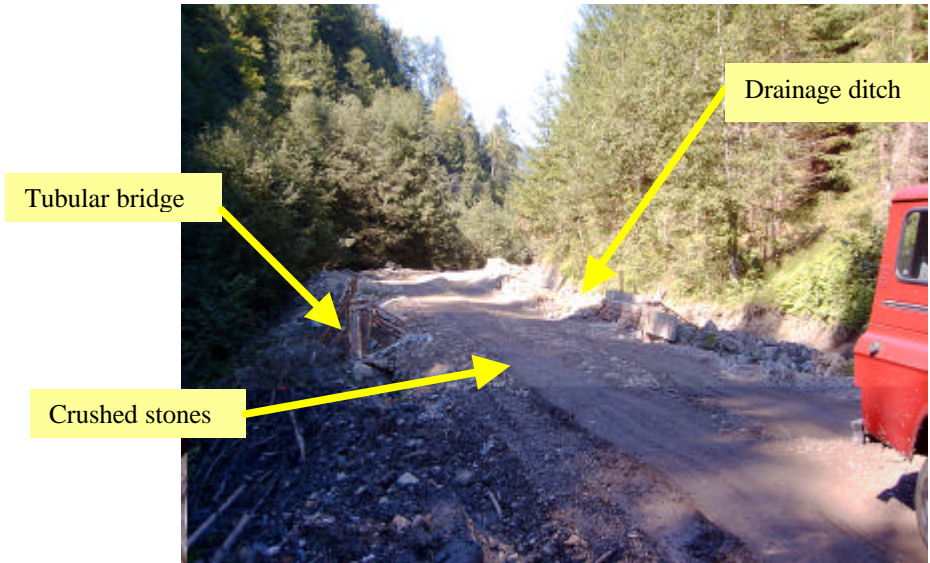
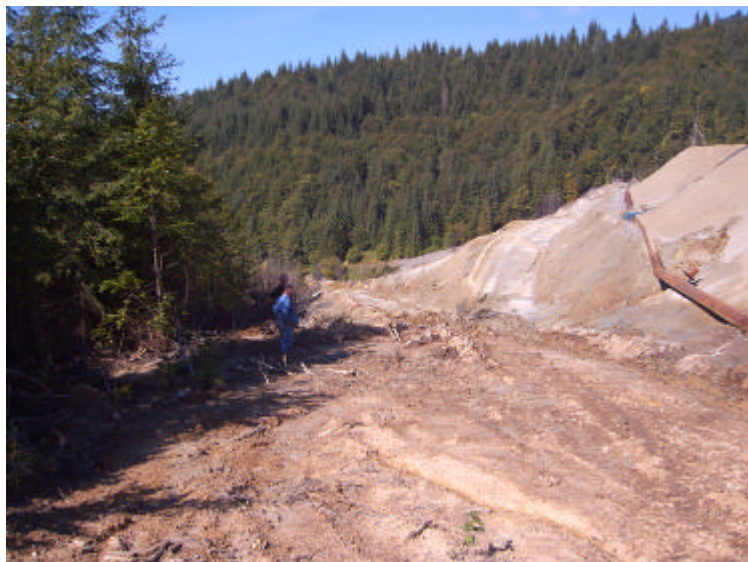
Two new access roads were built during the rehabilitation project to more easily reach the main units of the tailings pond, here the access from the top to the bottom (toe) of the main dam (photo: Horvath).

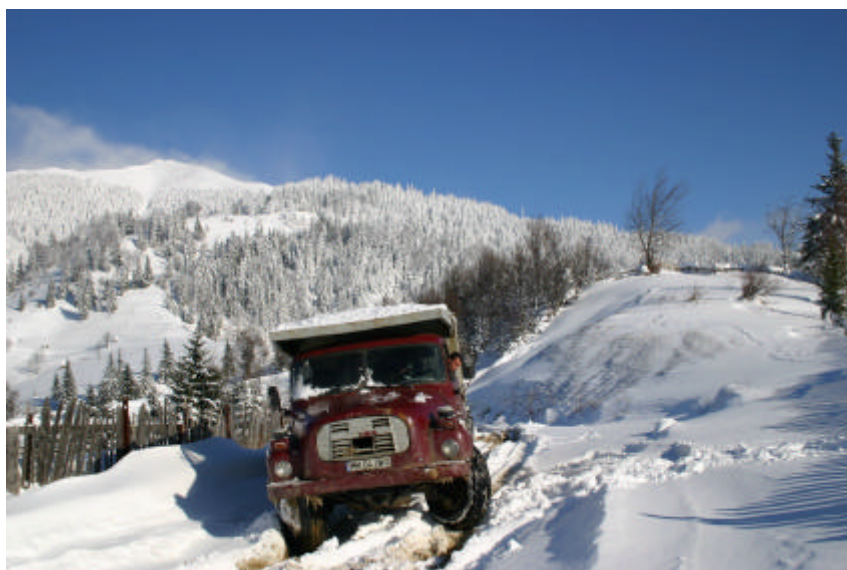
Only a few days after the completion of the Austrian support project, snowfall in the mountains around Baia Borsa made access to the Novat tailings pond again pretty difficult (photo: Timis/EM Borsa).
