**Stabilization and Safekeeping of the Tailing Pond Novat at
Baia Borsa, Maramures, Romania**

ANNEX to

FINAL REPORT

Photographic Documentation of Finalized Works

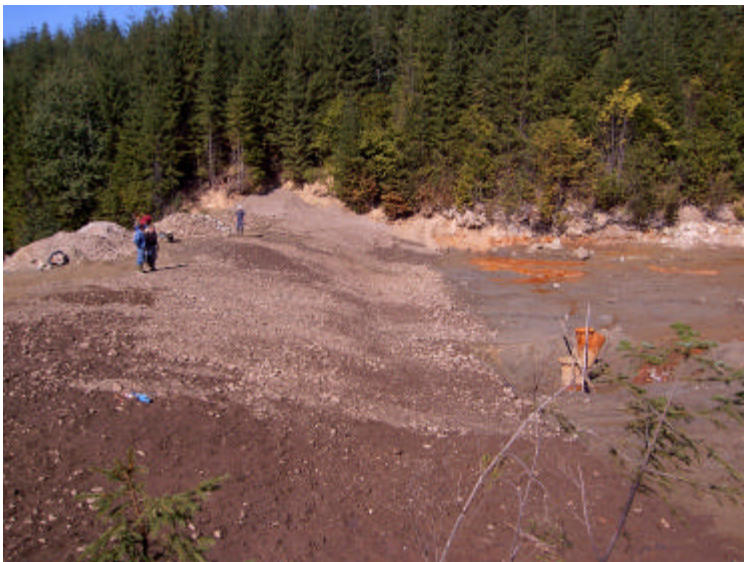
Exfiltration pond: The embankment was re-shaped and made water-tight with a geo-membrane (photo on top). A new emergency spillway was built on the central section of the dam (photo below).
